SAND94-0335 • UC-722

## Radiant Heat Testing of the H1224A Shipping/Storage Container

H1224A weapons containers have been used for years by the Departments of Energy and Defense to transport and store W78 warhead midsections. Although designed to protect the midsections only from low-energy impacts, a recent transportation risk assessment effort has identified a need to evaluate the container's ability to protect weapons in more severe accident environments. Four radiant heat tests were performed: two each on an H1224A container (with a Mk12a Mod 6c mass mock-up midsection inside) and two on a low-cost simulated H1224A container (with a hollow Mk12 aeroshell midsections inside). For each unit tested, temperatures were recorded at numerous points throughout the container and midsection during a 4-hour 121° C (250° F) and 30-minute 1010° C (1850° F) radiant environment. Measured peak temperatures experienced by the inner walls of the midsections as a result of exposure to the high-temperature radiant environment ranged from 650° C to 980° C (1200° F to 1800° F) for the H1224A container and 770° C to 990° C (1420° F to 1810° F) for the simulated container. The majority of both conta

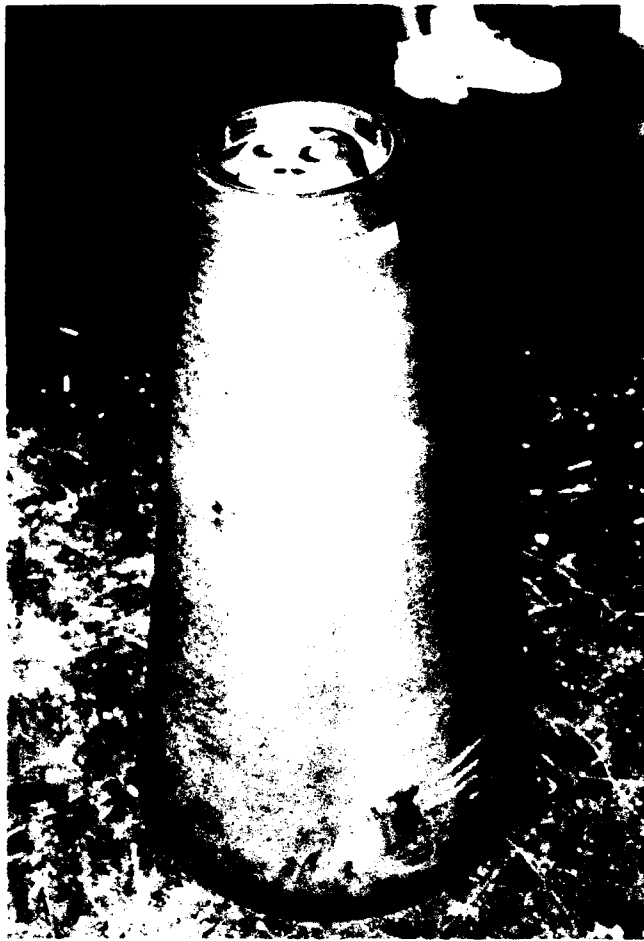
**Figure 3.7a Mk12 (W62) hollow aeroshell**

The W78 warhead midsection was simulated in the NAWC radiant heat test using a hollow W62 Mk12 midsection aeroshell, identical to that proposed (by DNA) for future use by China Lake in fuel fire tests. The aeroshell/heatshield consists of an approximately 13 mm (0.5 in.) carbon fiber reinforced phenolic over a thin aluminum substrate. The Mk12 aeroshell is virtually identical to that of the Mk12a except for the addition of four small radar windows near the aft end and slight differences in the aluminum substrate shape (see Figure 3.7). To eliminate convective cells, insulating blanket was used to fill the interior of the aeroshell.

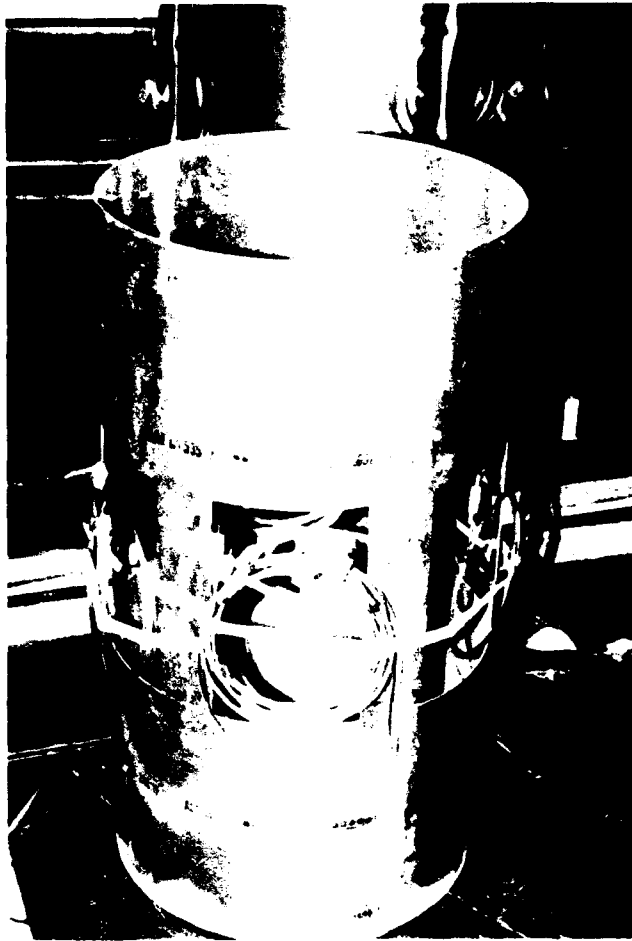
**Figure 3.9 NAWC inner container**

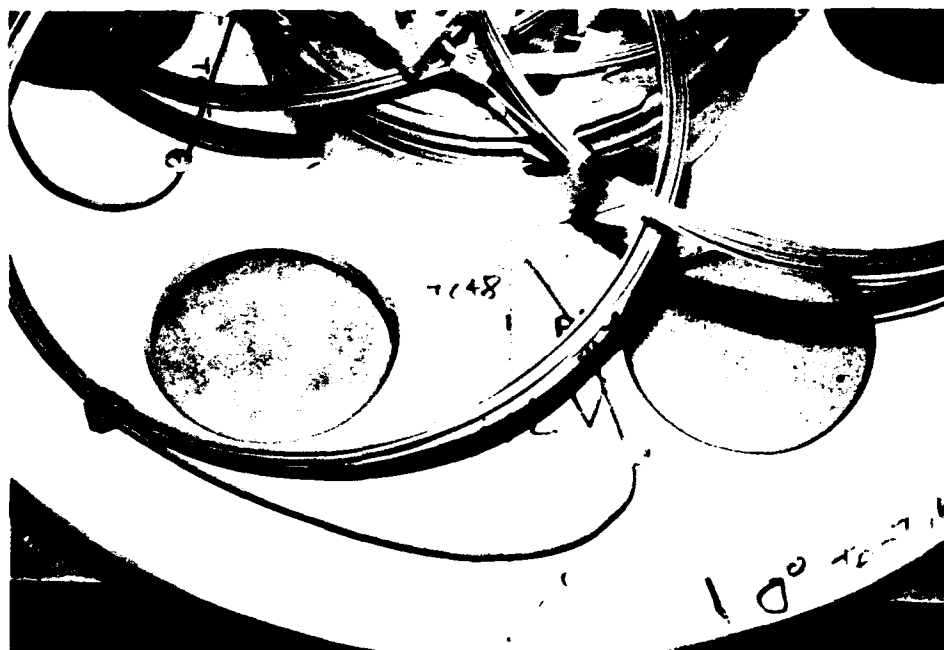
**Figure 4.8 Thermocouples attached to RV fore plate**

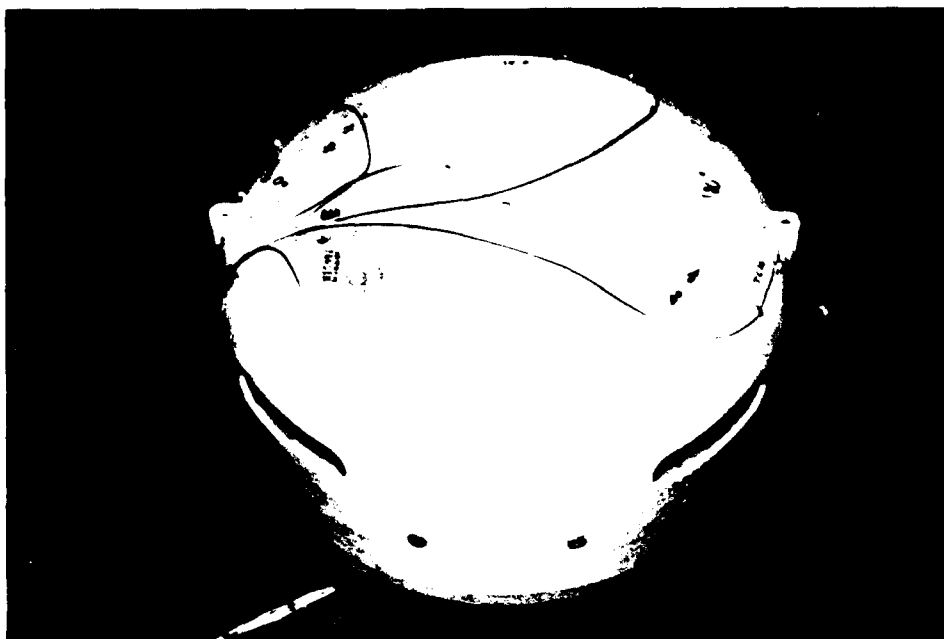
**Figure 4.11 Thermocouples on aft cover of Mk12 aeroshell**

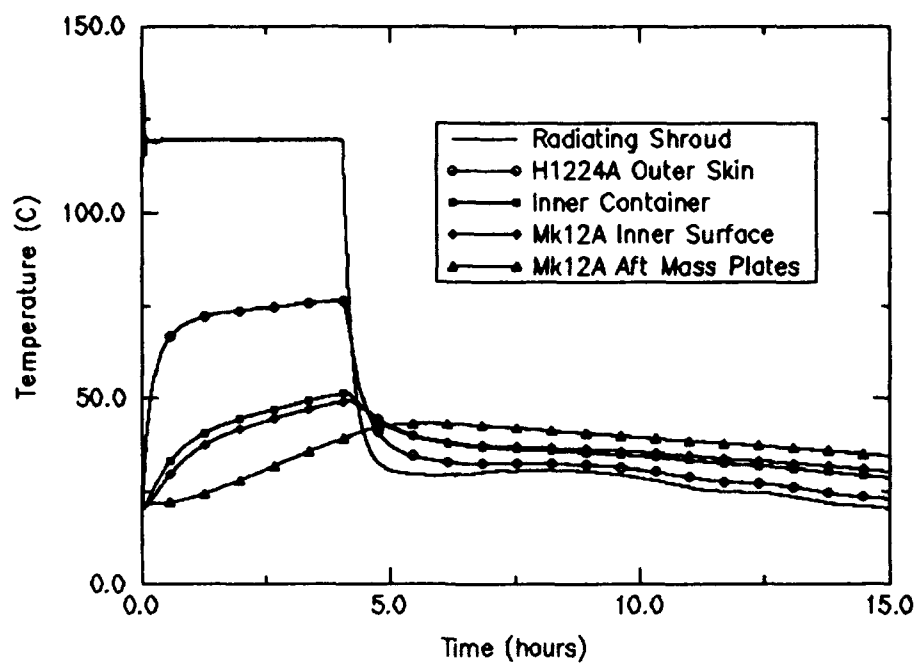
**Figure 5.1.1 Summary of 4-hour, 121° C H1224A radiant heat test temperature results**

A temperature history summary plot of mid-plane shroud, outer container shell, inner container, RV aeroshell inner surface, and aft weight plate temperatures is shown in Figure 5.1.1. Although only one temperature point in each layer (shroud, outer shell, etc.) is shown, other comparable thermocouples around the circumference of each layer recorded similar temperatures. The aft weight plate group reached its peak temperature of 43° C (110° F) about 5.6 hours after the beginning of the test. The fore weight plate group reached its peak temperature of 35.5° C (96° F) about 7.5 hours after the beginning of the test. The aft section of the Mk12a aeroshell substrate reached its peak temperature of 48° C (118° F) about 4.2 hours after the beginning of the test, and the fore section of the Mk12a aeroshell substrate reached its peak temperature of 45° C (113° F) about 4.2 hours after the beginning of the test. Individual thermocouple temperature histories for the 4-hour 121° C radiant heat test of the H1224A container are presented in Appendix A. Peak temperatures are compared for each of the four tests in Table 5.1.

Although the midpoint of the shroud was maintained at a constant 121° C during the 4-hour test, thermocouples near the top of the shroud around its circumference (S1-S6 in Figure 4.2) recorded temperatures of approximately 80° C (176° F). Thermocouples on the lower shroud (S13-S18) recorded temperatures of about 38° C (100° F). The top shroud cover plate's center thermocouple (S20) recorded steady test temperatures of approximately 76° C (169° F). This variation is due to edge effects in the application of radiant heat from the lamp arrays to the shroud. Near the top and bottom, the radiation view factor between the lamp array and shroud becomes less than 1.0 (>0.8 at the array edge), unlike near the center or midplane of the shroud. The upper shroud temperatures are greater than the lower ones due to heated air rising between the lamps and shroud. The top cover shroud does not reach the target test temperature due its relatively weak heat source from above.

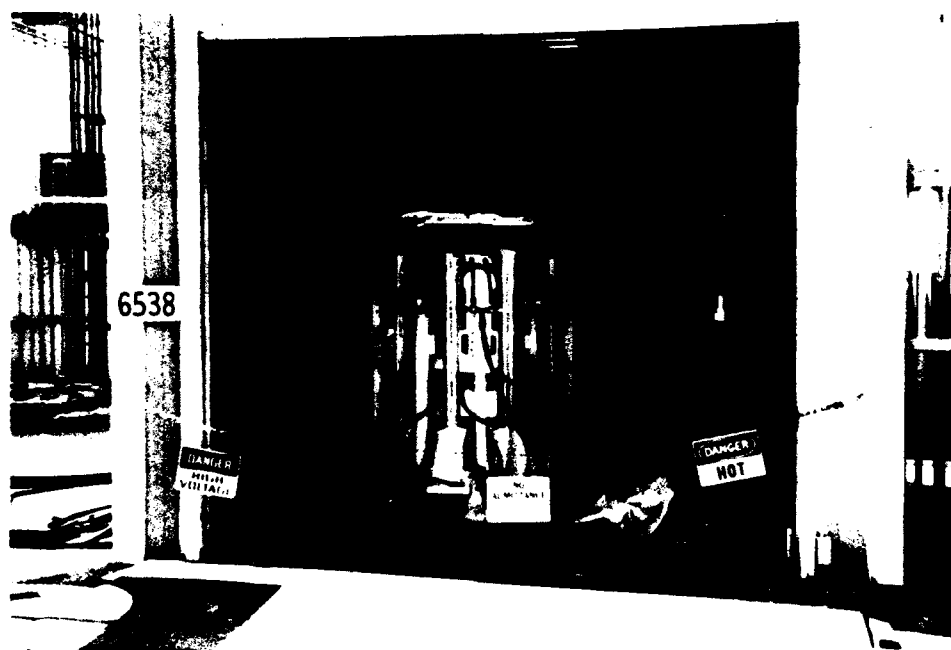
Figure 5.2.1 H1224A radiant heat test: pre test

The pre-test setup of the H1224A test is shown in Figure 5.2.1. The lamps initially ramped up to nearly peak power in an attempt to bring the temperature-controlling shroud thermocouples up to their required 1010° C, as shown in Figure 5.2.2, about 10 seconds into the test. The light smoke being generated in Figure 5.2.2 is probably degradation of the zinc chromate paint on the outer surface of the container. As shown in Figure 5.2.3, darker smoke from foam degradation could be seen after only about 45 seconds into the test. After about 4 minutes, combustion of the foam volatiles near the vents outside the radiant shroud peaked, as shown in Figure 5.2.4. An example of the volume of smoke generation is presented in Figure 5.2.5, showing light brown smoke forced out the top of the test facility by four exhaust fans. This smoke generation remained approximately constant from about 7 to 22 minutes into the test, with characteristic burning of foam volatiles, as shown in Figure 5.2.6.

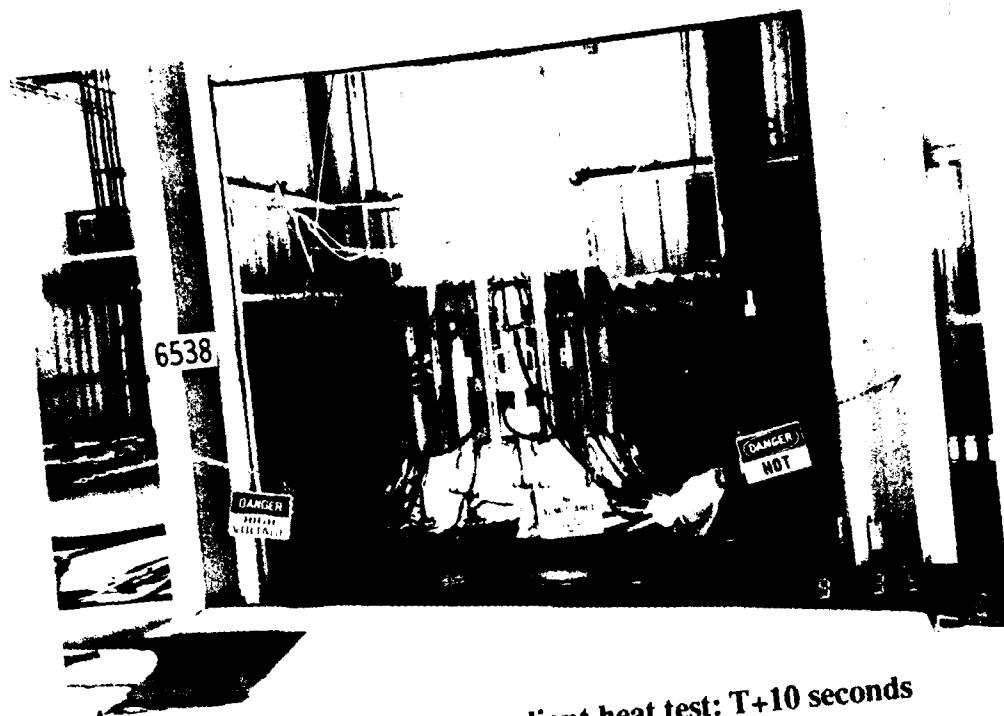
Figure 5.2.2 H1224A radiant heat test: T+10 seconds

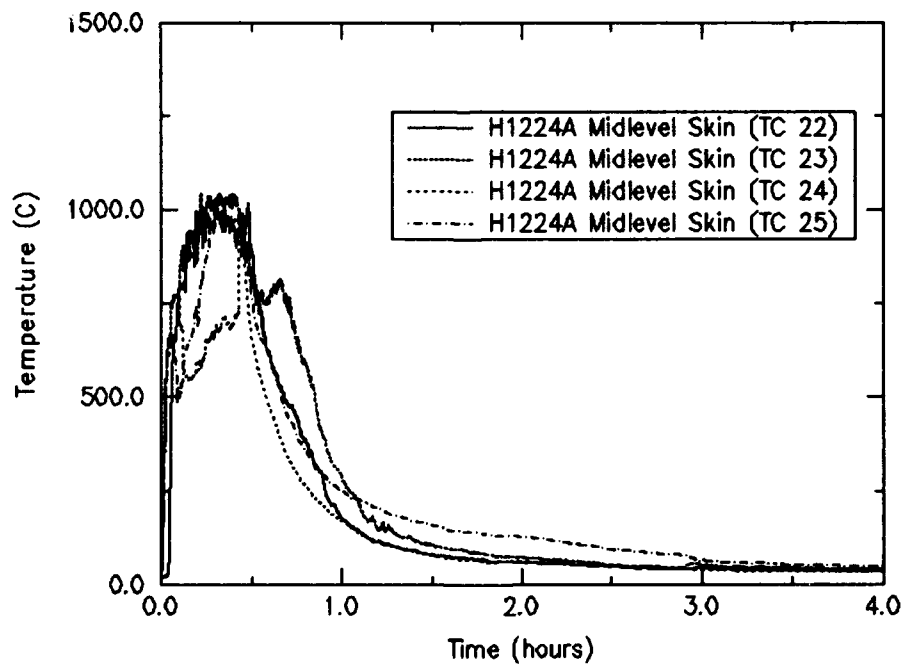
**Figure 5.2.13 H1224A 30-minute radiant heat test container skin temperatures (midplane)**

Temperature histories for the midplane shroud thermocouples are shown in Figures 5.4.14 and 5.4.15, highlighting the uniformity in thermocouples S7-S10 and the sporadic readings in S11 and S12 during deterioration due to corrosion. The subsequent temperature profiles of the NAWC outer container shell is shown in Figure 5.4.16, whose variation is not significantly greater than that observed in the outer shell of the H1224A high-temperature test (Figure 5.2.13).

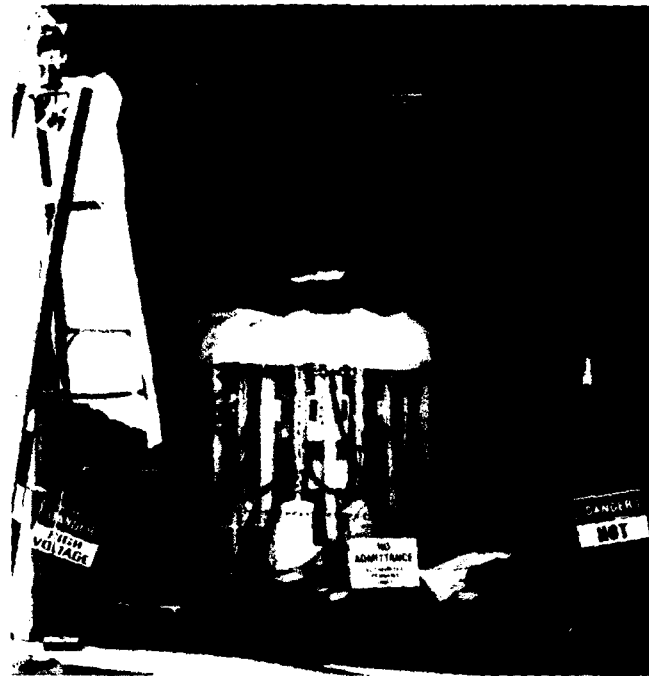
**Figure 5.4.1 NAWC radiant heat test: pre test**

The pre-test setup was virtually identical to that of the H1224A test, with the exception of additional insulating cloth around the top and bottom of the lamp arrays to avoid thermal degradation of rubber water hoses (see Figure 5.4.1). As power was applied to the lamp arrays at the beginning of the test, the lamps initially ramped up to nearly peak power in an attempt to bring the temperature-controlling shroud thermocouples up to their required 1010° C, as shown in Figure 5.4.2, about 10 seconds into the test. As shown in Figure 5.4.3, no smoke from foam degradation could yet be seen, even though the shroud had been up to test temperature for approximately 6 minutes. After about 7 minutes of high-temperature heat application, off-gassed volatiles began to burn near the vents outside the radiant shroud, as shown in Figure 5.4.4. The generation of volatile gasses continued to increase, as did their burning, seen in Figure 5.4.5 at approximately 8 minutes into the test.

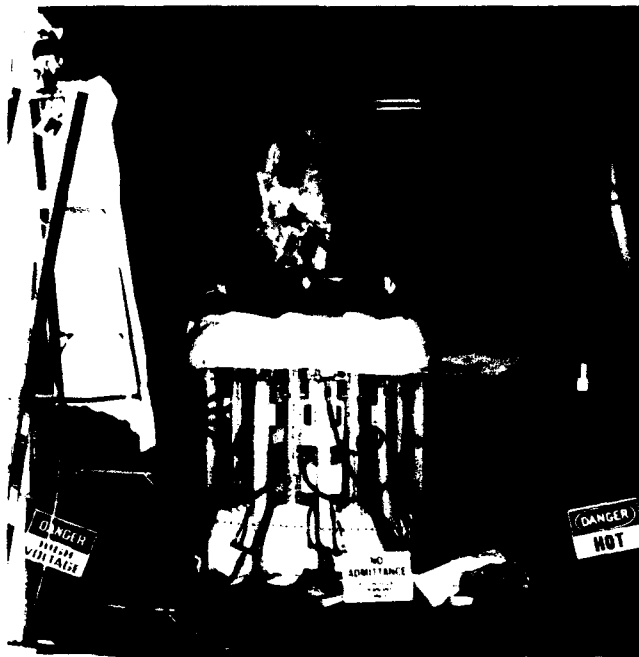
**Figure 5.4.7 NAWC radiant heat test: T+17 minutes**

Unfortunately, a mishap occurred about 11 minutes into the radiant heat test. Melting aluminum from the NAWC container came in contact with two of the lamp array temperature-controlling shroud thermocouples (S11 and S12 at 240° and 300°, respectively, with 0° closest to viewer of test). The molten aluminum began to corrode the inconel-sheathed thermocouples and deteriorating their junction, causing sporadic temperature readings. This caused the temperature control system to supply excessive power to these two pairs of lamp arrays, as shown by the bright areas of the shroud in Figure 5.4.6, which thus caused failure of many individual bulbs in those arrays (note the subsequent darker shroud areas in Figure 5.4.7).

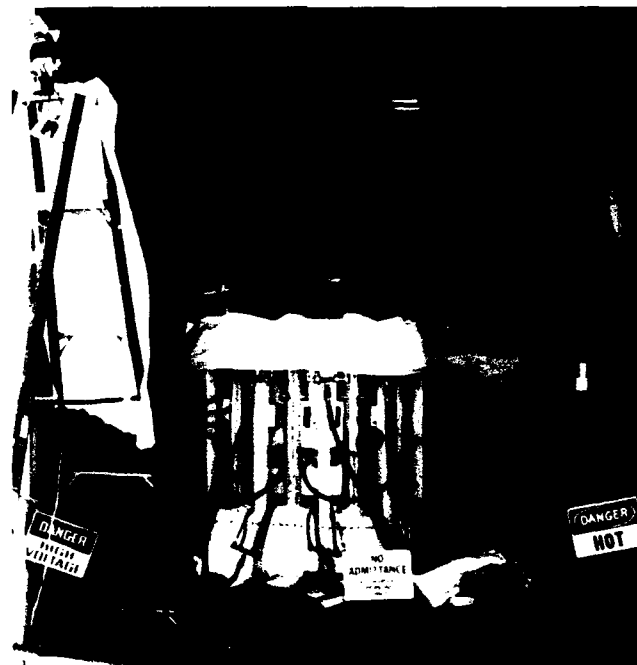
**Figure 5.4.8 NAWC radiant heat test: T+29 minutes**

Volatile gas generation and exterior burning of these gasses continued through the end of the test (see Figure 5.4.8, 29 minutes into the test). Even after application of radiant heat ceased, the surrounding air temperature was sufficient to promote burning of the generated off-gasses, as shown in Figure 5.4.9, 2 minutes after cessation of radiant lamp power. Deterioration of the radiant shroud due to corrosion and failure of individual radiant lamps is shown in the post-test photograph, Figure 5.4.10.
